# HOW NOT TO MEASURE GAS - ORIFICE

Dee Hummel – Targa Resources

Presented by John McDaniel - Williams

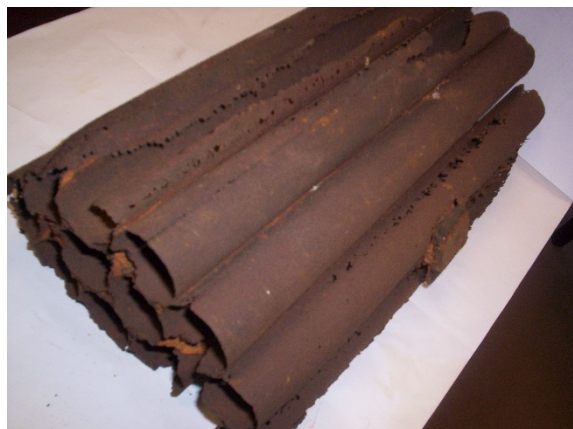
Straightening vanes were recommended to be fabricated out of stainless steel material. Stainless is resistant to corrosion. However, if the vanes were made from carbon steel and placed in a corrosive environment, the vanes will rust. Once this happens, the upstream profile will change, and cause a measurement error. Depending upon the location of the vanes, the error can be either positive or negative.

A high carbon dioxide concentration in a wet gas stream creates a corrosive environment. After a few years in service, the vanes can look like the picture below:

**FIGURE 1. Corroded Straightening Vanes**

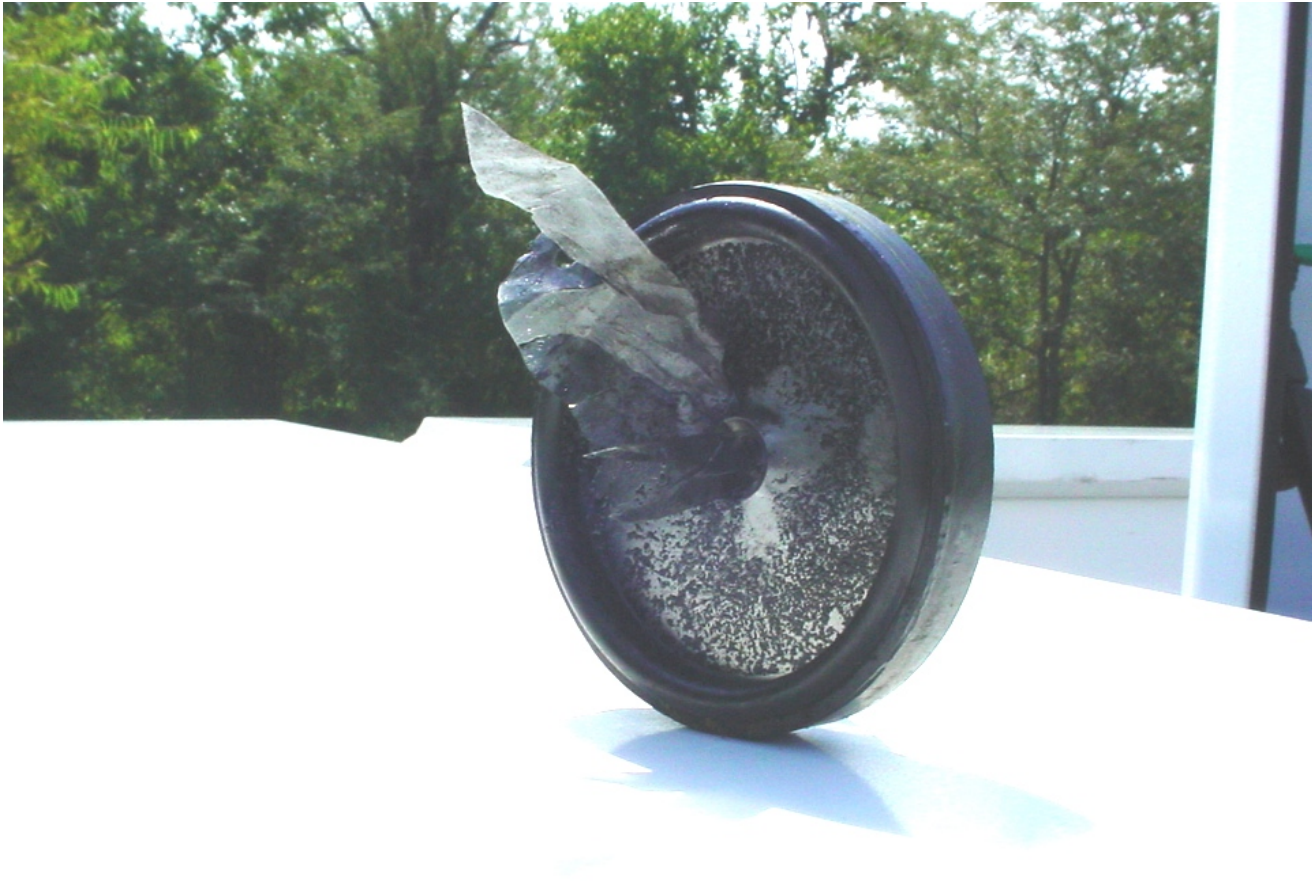
When a new installation is commissioned, it is always a good idea to purge the pipeline or facility prior to putting the measurement station into service. If the pipeline or measurement facility is not adequately purged, debris left in the pipe may end up in the meter tube. Any type of debris can be left in a pipeline during construction; the picture below shows a piece of plastic that was left in the upstream portion of the meter tube.

**FIGURE 2. Orifice Plate Plugged with Debris**

The effect of the plugged orifice plate is reflected in the EFM data collected from the meter site. On the 21<sup>st</sup>, the flow was completely restricted. As the plastic pushed through the orifice bore it effectively decreased the size of the orifice bore overstating the differential pressure and the volume.

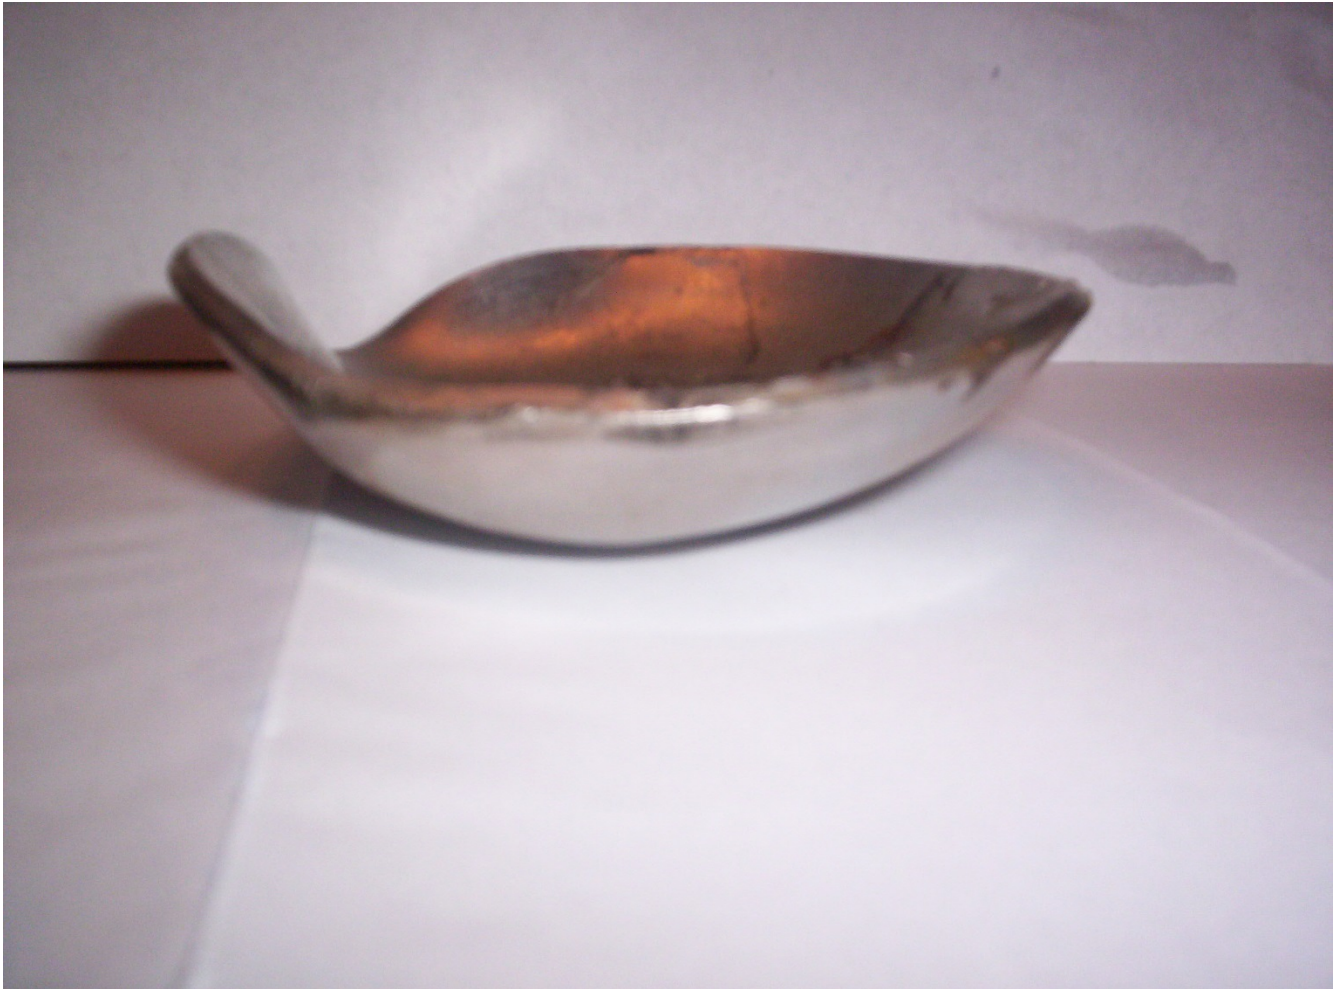
In older installations, vane bundles may become loose and move inside the meter tube. The vanes may partially block the upstream tap hole, or may hit the orifice plate. The orifice plate in the picture below was damaged after the straightening vanes came loose inside the meter tube.

**FIGURE 4. Orifice Plate Damaged by Loose Straightening Vanes**

It is not uncommon for hydrates to form in the winter months. If the vane “pin” is weak or damaged, the velocity of the gas flow may cause the hydrate to move and hit the vanes. Once the pinning device is compromised, the vanes will move downstream with the flow.

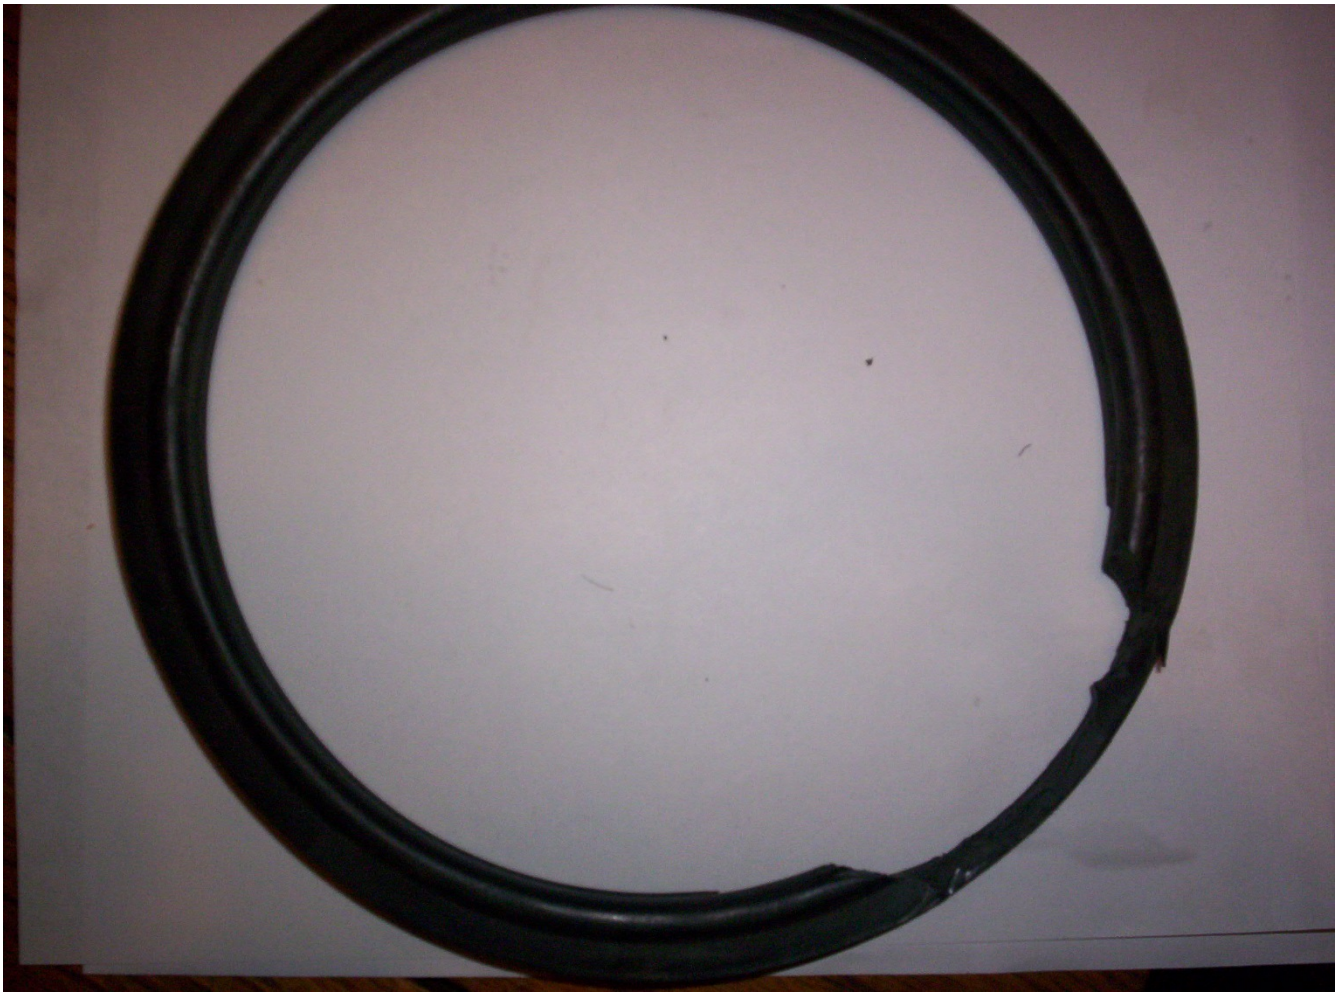
Other problems occur with sealing devices. Whether the meter run is a single or dual chamber, the seal ring is always important to examine when doing a meter inspection. In extreme conditions, the seal ring can become “swollen” from exposure to rich gas streams. When that occurs, the seal ring may tear when removing it from the meter tube.

**FIGURE 5. Torn Seal Ring**

The picture above illustrates the effect of extended exposure to a rich hydrocarbon gas stream. The seal ring swelled, and the seal tore as the plate was removed from the meter tube. Always be selective on the type of seal ring, and the ANSI rating of the fitting. Be sure to install the correct ANSI rating series seal ring in the meter tube. Installing the wrong ANSI rated seal ring, may not seal the orifice plate in the plate carrier or meter run and may cause a protrusion into the meter tube which is not allowed.

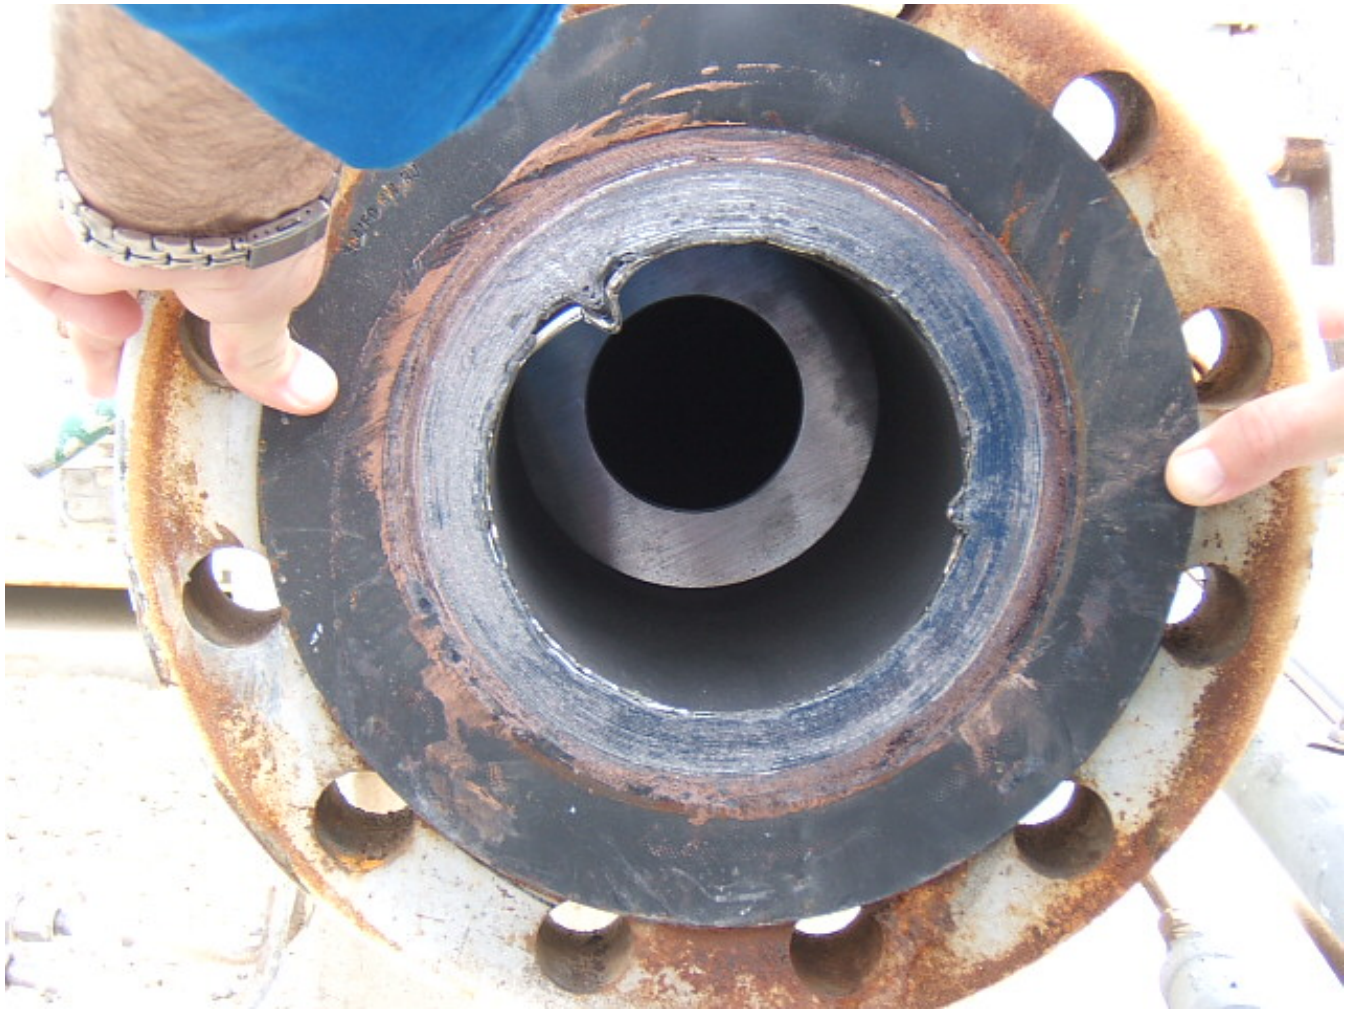
Caution should be taken to make sure that the flange gaskets do not protrude into the meter tube bore. This induced error can be either a positive or negative in nature. It is important to make sure that the proper size and ANSI rated flange gasket is used in the meter tube. The picture below illustrates the effect of the wrong size gasket upstream of the orifice plate. Note the deflection of gas, as evidenced by the shaded area of the tube and plate.

**FIGURE 6. Incorrect Gasket Size Example**
