## Two Case Studies on Installation Effect

Allen Clark

Atmos Energy

Two Case Studies:

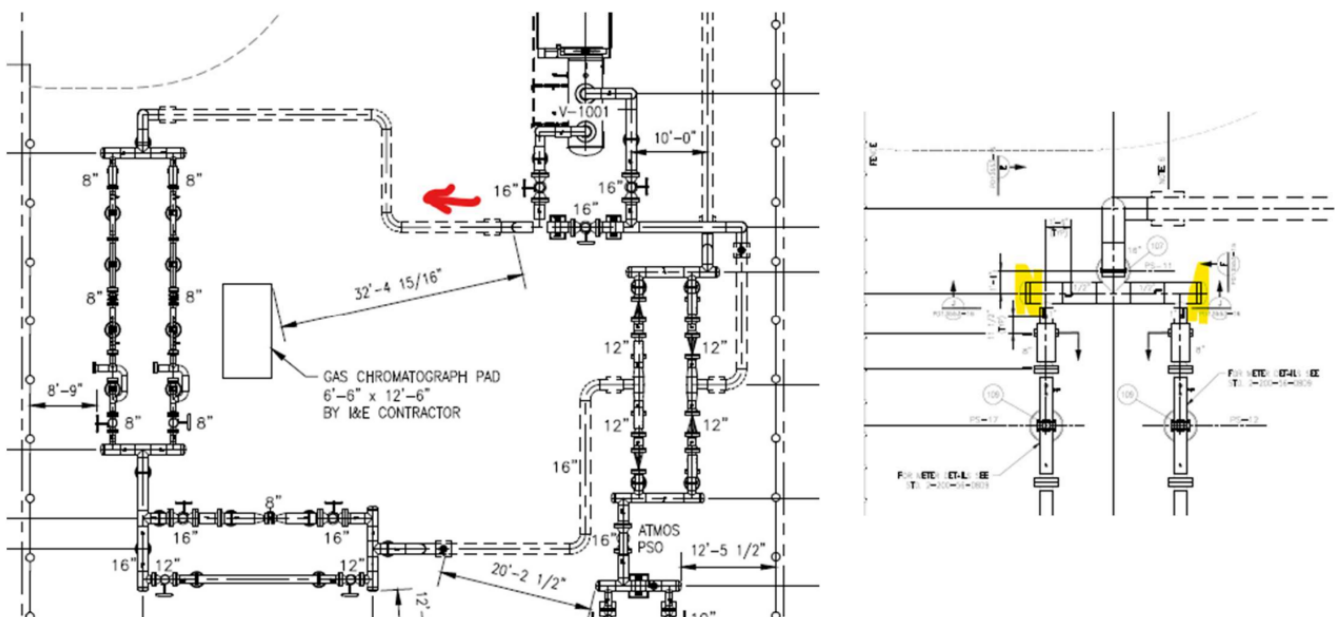
1. Two 8" meters were calibrated. During calibration the profile factor for both meters were very close, across the flow range, averaging a 1.16.
2. The meters were put in service. When run 1 flowed by itself, the run's profile factor matched reasonably close to the expected profile factor
3. However, when the meters flowed in parallel, run 1's profile factor shifted low by more than 5% indicating error (on the order of +/- 0.2%) caused by the station piping when the meters were operating in parallel
4. Solution: Installed additional flow conditioners at the upstream in up both meter tubes which resolved the issue. Following the work, both meter's profile factors averaged very close to the expected profile factor determined from the calibration data

Figure 1: Diagram of Meter Station with Highlight of parallel meter runs on left.

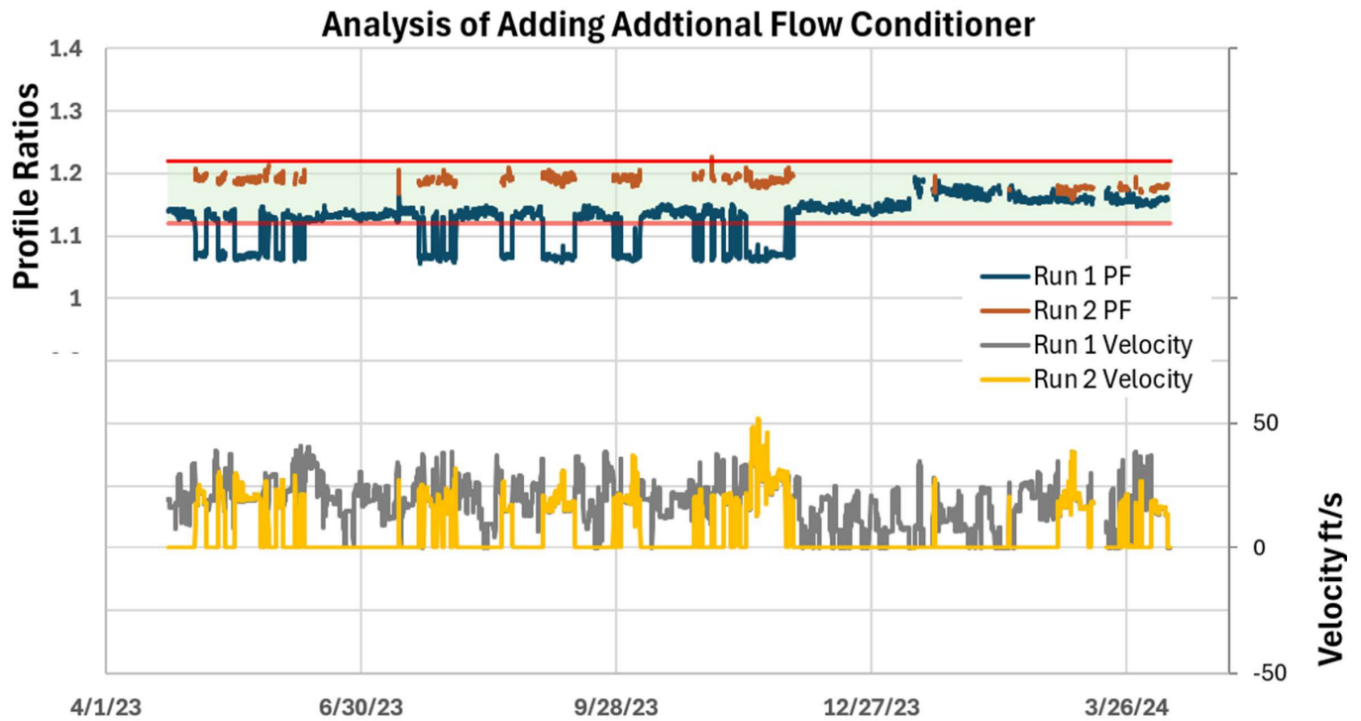
Figure 2: Analysis of adding an additional flow conditioner

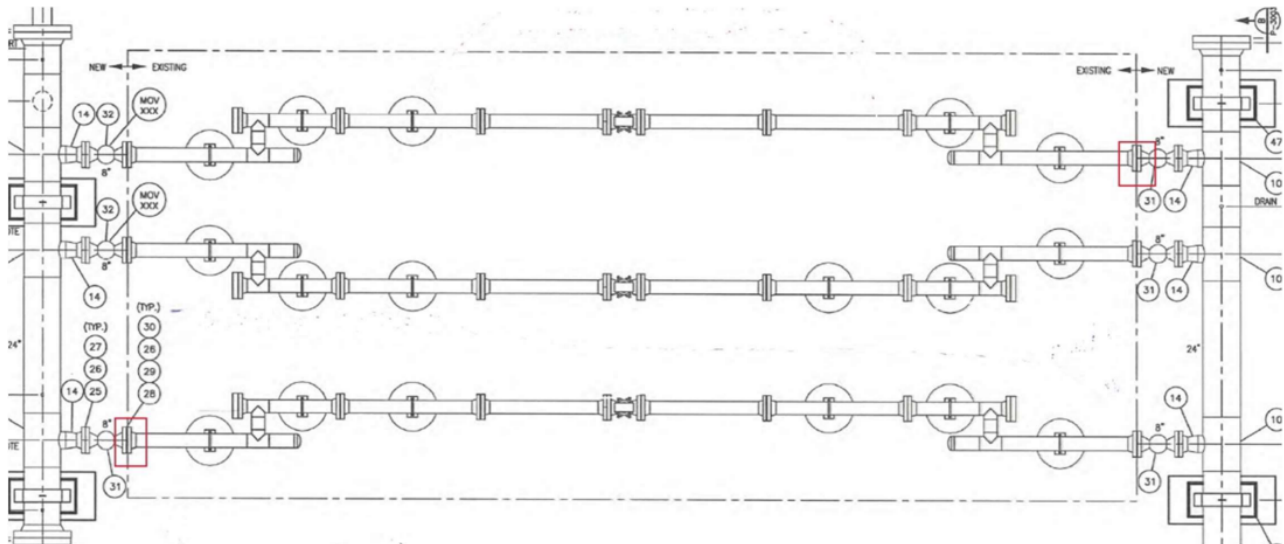
Figure 3: Bidirectional Meter Run Sight with similar issues fixed using two flow conditioners.

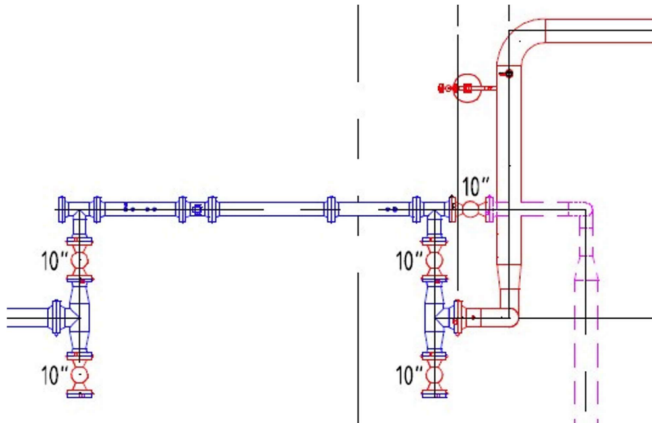
1. 10" USM has been in service for many years. The meter became undersized as demand increased over time. This increased flow through the meter to the point where audible noise being generated by the flow conditioner became an issue.

Figure 4: Diagram of installation of 10" USM

3. Solution: The station upstream header and piping was redesigned to meet current standards, adding a parallel meter, and the USM was recalibrated with the less restrictive flow conditioner. Once the meter was calibrated with the new conditioner, the USM's flow profile factor and symmetry began matching the calibration, thus solving the distorted gas profile issue.

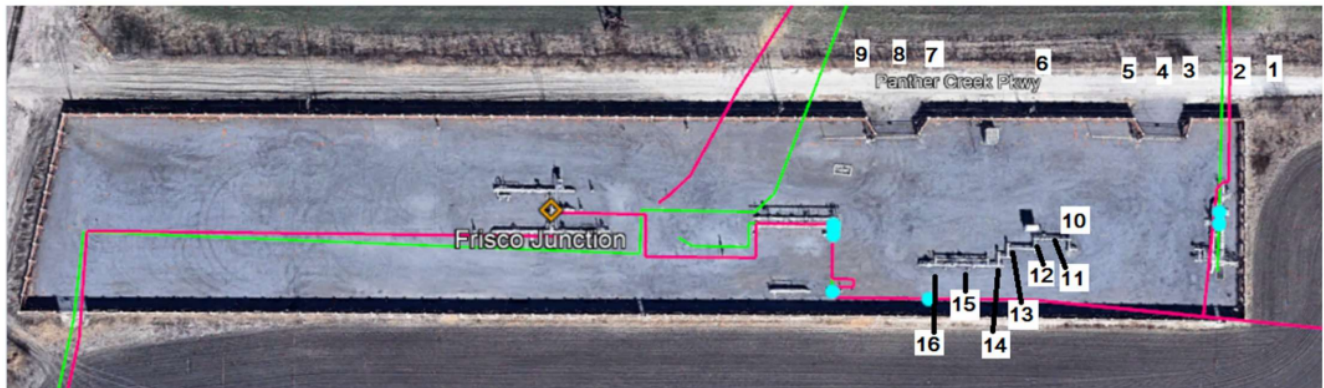
Figure 5: Photo of actual installation

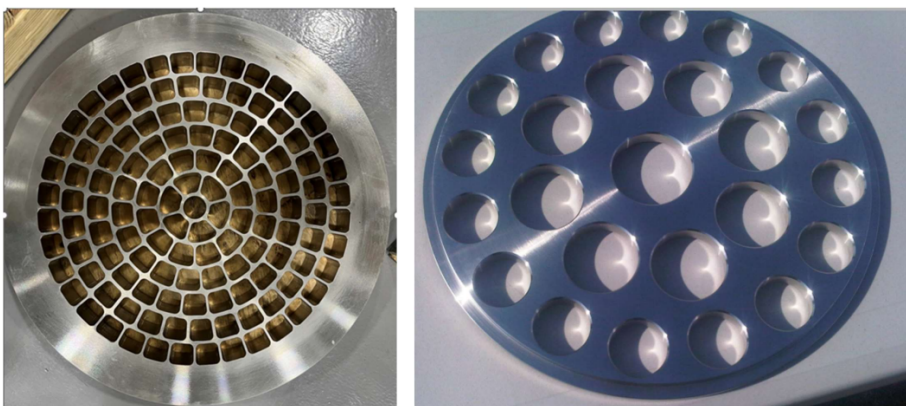
2. The decision was made to replace the more restrictive flow conditioner with a less restrictive conditioner. The conditioner significantly reduced the audible noise but did not handle the disturbed flow profile caused by the upstream piping causing appreciable installation effect error (up to  $\pm 0.7\%$ ). A solution was needed for the installation effect.

Figure 6: Photo of Less Restrictive Flow Conditioner vs. More Restrictive Original Flow Conditioner

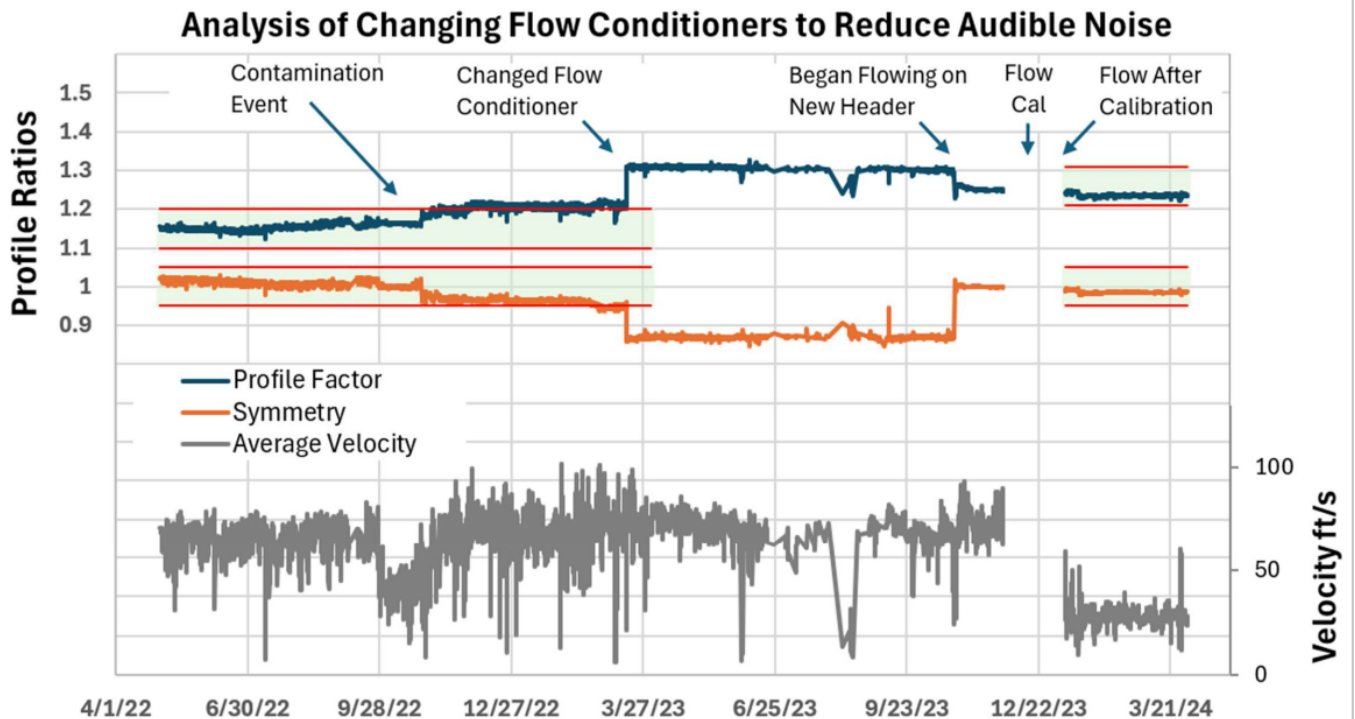
Figure 8: Analysis of changing flow conditioners to reduce audible noise.
