# HOW NOT TO MEASURE GAS - ORIFICE

Dee Hummel – Targa Resources

Presented by John McDaniel - Williams

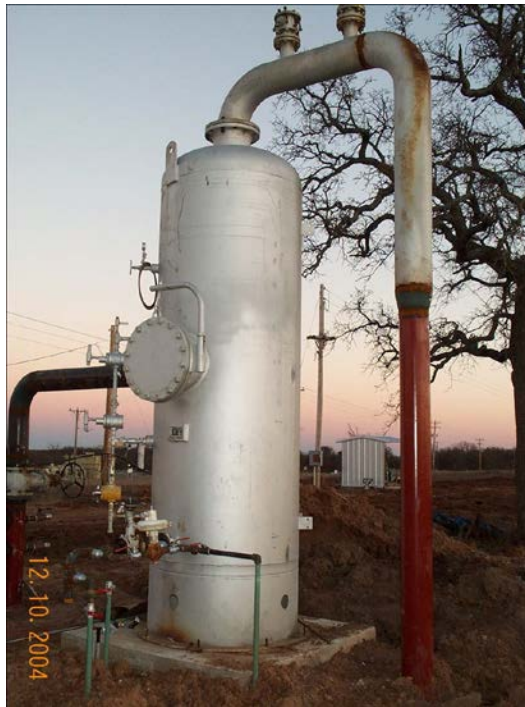
**FIGURE 7. Vertical Separator**

When new gas sources are added to a gathering or transmission system, it's always a good idea to review the type and amount of gas that is added to the system. In gathering systems, it is important to confirm that any separation equipment is sized properly to handle the additional volume. If the vessels are undersized, the free water or condensate can carry over the top of the vessel and interfere with the downstream measurement. Again, the upstream flow profile is affected; the amount of error is dependent upon the quantity of carry over liquids.
